Tree Survey Report

Arklow Wastewater Treatment Plant Project

29 August 2018

6572_Appendix 13.2_Tree Survey Report

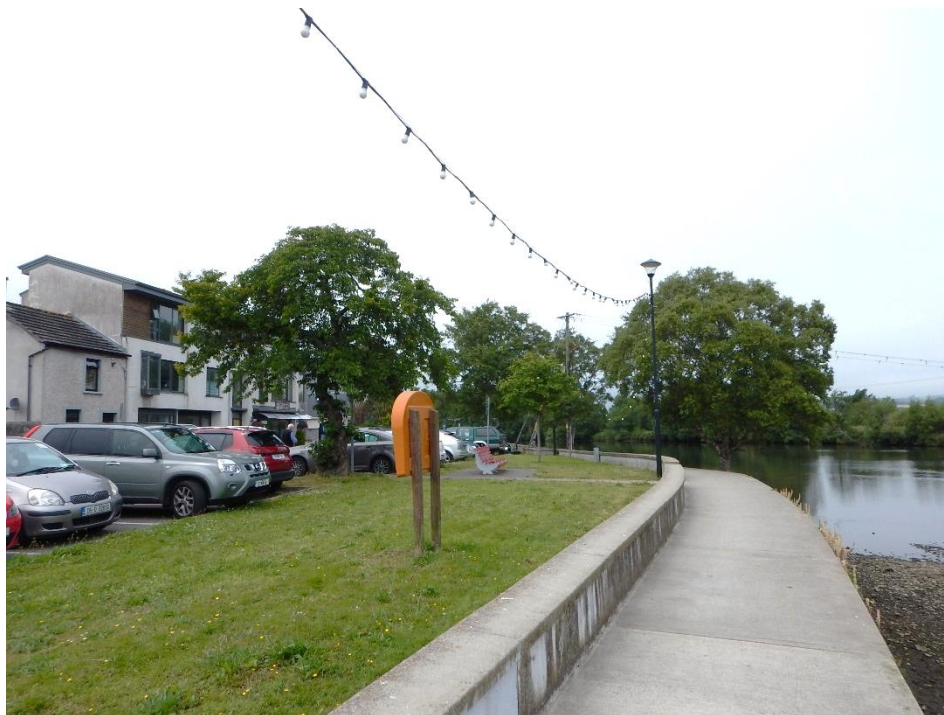
The area to the west of the bridge on the southern bank included trees numbered T1-T32; these trees are mostly growing in linear green open space along the footpath and river bank and provide moderate to good amenity and landscape value. Most of the trees are not of especially high arboricultural value as individuals; although there are several trees graded as category B, most notably the Weeping Willows (T25, T26 and T29) at the far western end of the survey area and Ash tree T22.

Photo 1. Trees established along the southern river bank; to the west of the road bridge

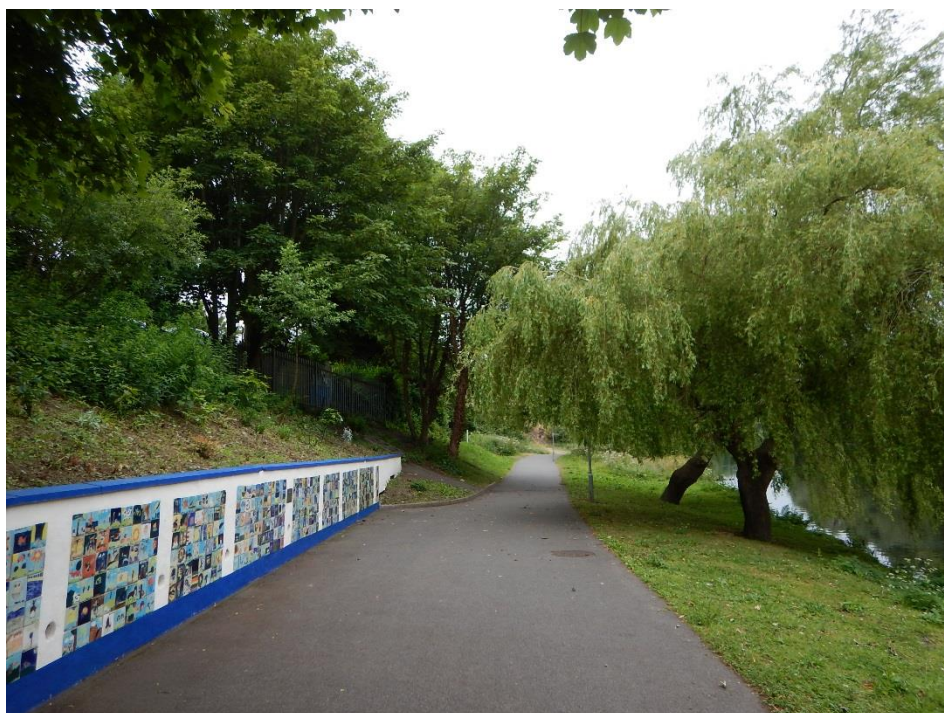
Photo 2. Willow trees on the southern bank of the river towards the western end of survey area

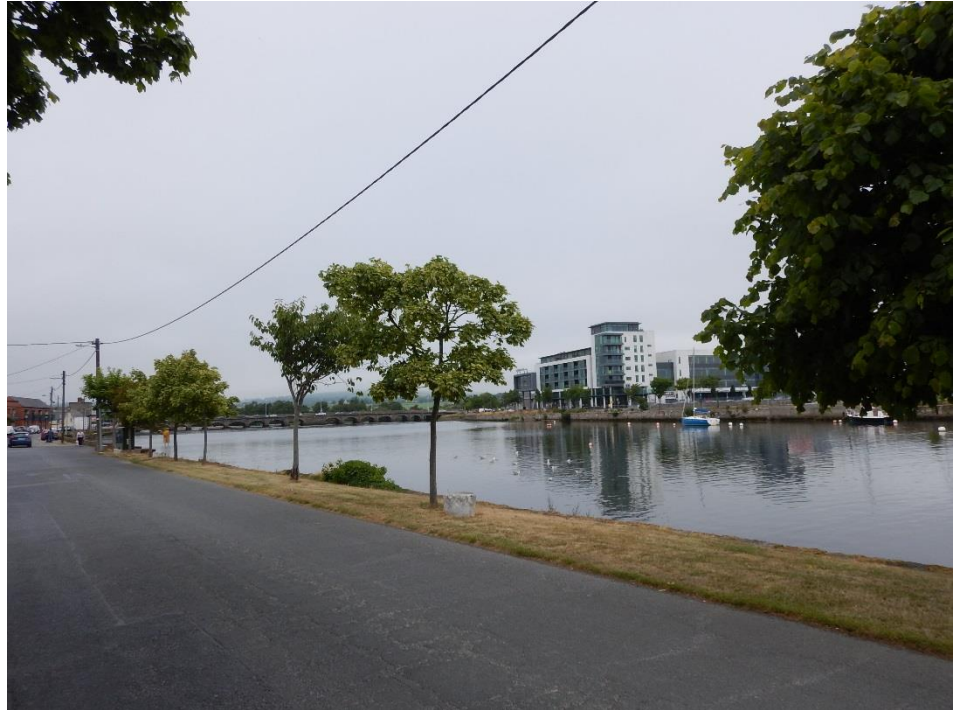
The trees included in the schedule to the south-east of the bridge are all smaller, young trees of fairly low quality and value. The trees do provide some amenity value, however the poor growing environment and species selection is likely to mean that this contribution will remain limited into the future.

Photo 3. Young trees established in the grass verge along the southern bank of the river, south-east of the bridge

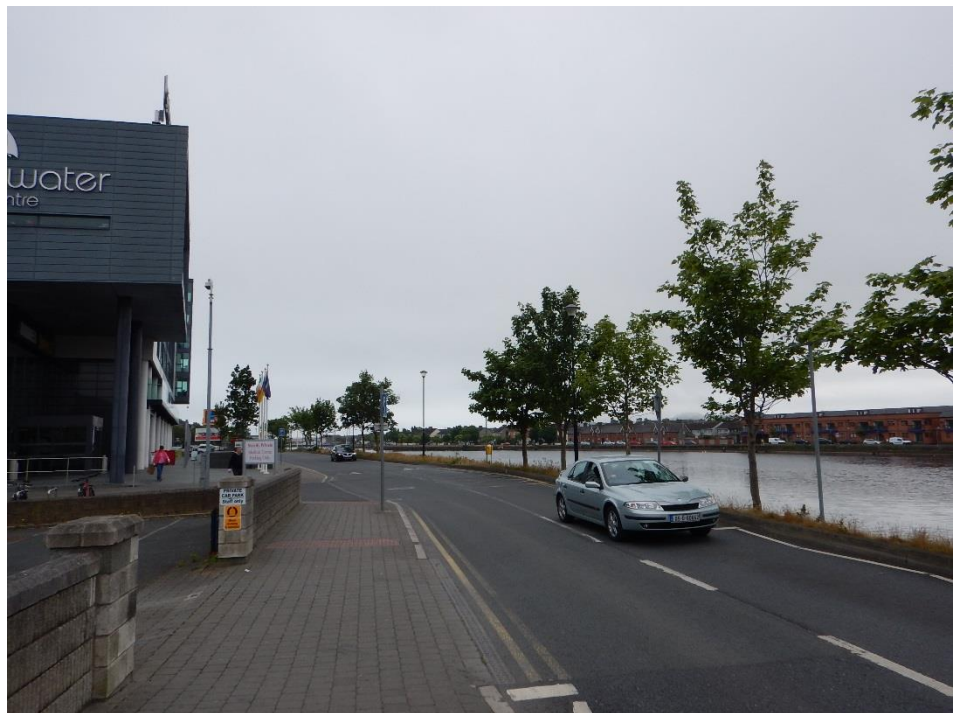
The small young Maple trees numbered T73 - T98 have been planted along the northern side of the river in the narrow verge between the traffic barrier and riverbank. Most of these trees have struggled to become established in the restricted growing environment and are now in poor physiological condition and are of low value. The linear group of Poplars (T99-T104) appear to be in mostly fair physiological condition, however they are an inappropriate species for such a restricted growing position; they are already disturbing the adjacent tarmac road surface and could cause structural problems for the quayside wall in the future.

Photo 4. Young trees established in the verge along the northern bank of the river, south-east of the road bridge

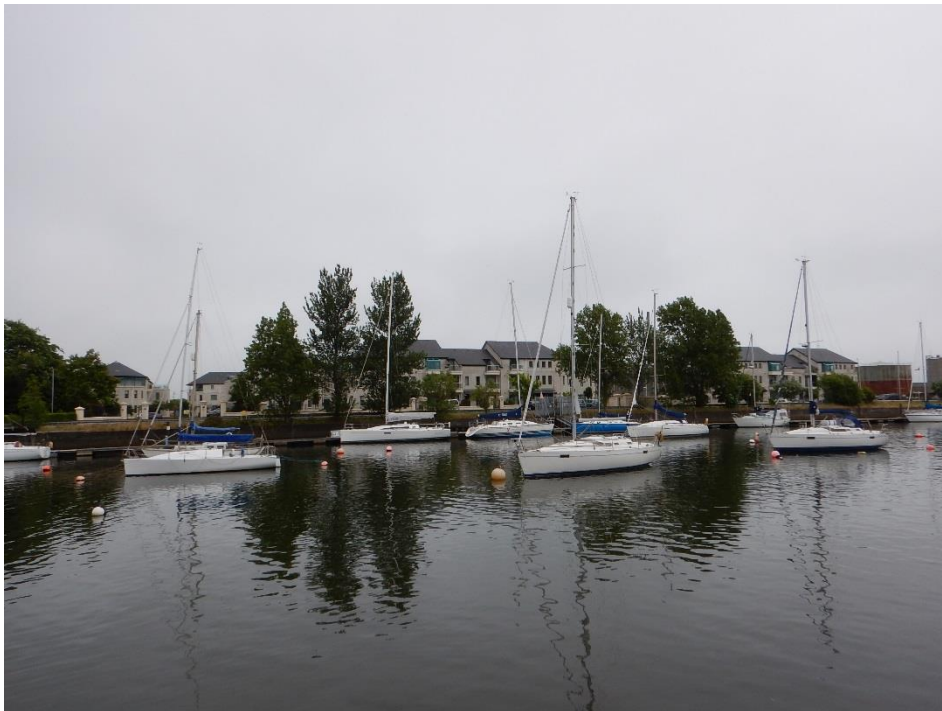
Photo 5. Linear group of Poplar trees along the northern bank of the river, at the eastern end of the survey area

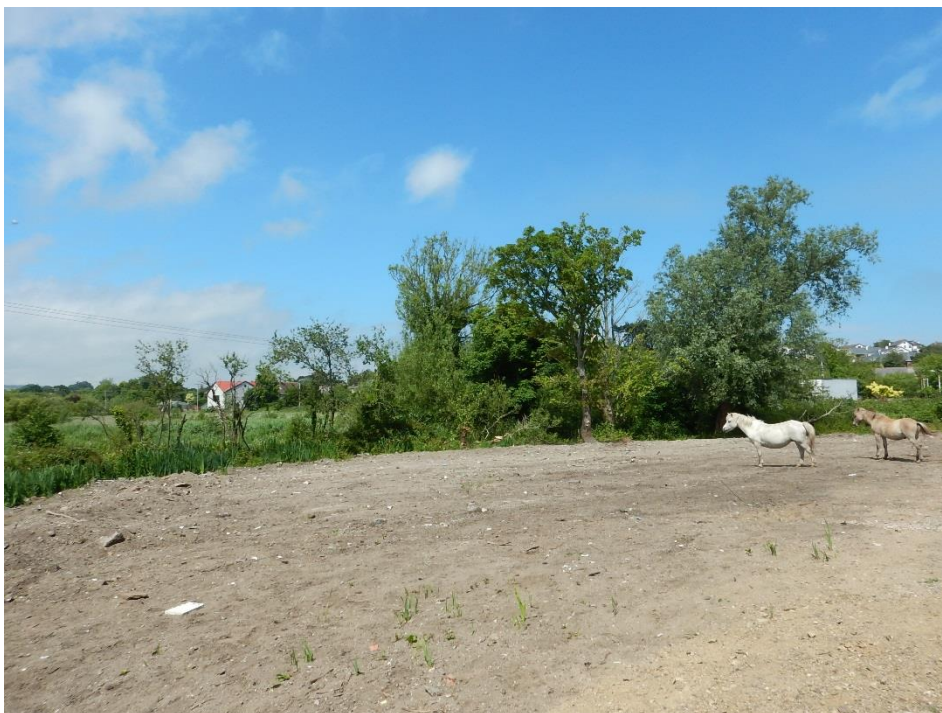
Photo 6. Mixed willow scrub (G3 in the survey schedule and survey drawing) and trees 105-107 at the northern end of the survey area

T105	Salix fragilis (Crack Willow)	M	16	1200	1	2	7	8	5	4	10+	Fair	Poor. Large old tree that looks to have been previously pollarded, but that now has a significant crown. Ganoderma spp. brackets on lower stem indicating significant basal decay. Recent root damage. Tree now vulnerable to stem and/or branch breakage.	Carry out partial pollard by reducing crown size and height by 50%.	14.4	652	C2
T106	Acer pseudoplatanus (Sycamore)	M	13	566	2	2	5	5	5	5	<10	Bad	Poor. Tree is dying; probably as a result of significant previous root damage. Significant dieback in crown.	Fell tree; try coppicing to allow regeneration of fresh growth.	6.79	145	U
T107	Acer pseudoplatanus (Sycamore)	EM	10	350	1	2	3	5	4	3	<10	Poor	Fair/Poor. Low vitality. Recent significant root damage likely. Dieback in crown, leaf size small for species and foliage pale in colour/chlorotic.	Monitor tree condition. Consider coppicing to allow regeneration of fresh growth.	4.2	55	U

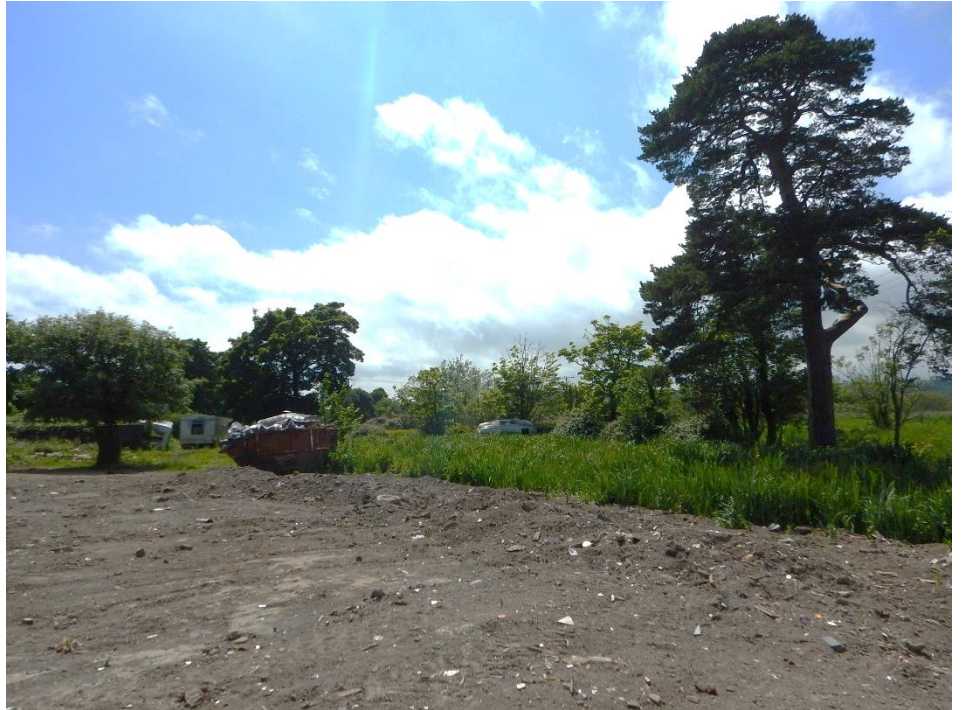
The land in the survey area to the west of the properties along the west side of the R772 (Ferrybank) includes significant areas of wetland and dense scrub that was not accessible by foot. The part of the area that was accessible had been left derelict for some time, but has recently been worked over by machinery. Many of the trees are in poor condition, however one Pine tree (T108) remains in fairly good health.

Photo 7. Scots Pine tree 108 along with some poor quality Willow bushes at the edge of the wetland

T108	Pinus sylvestris (Scots Pine)	M	15	750	1	3	4.5	5	5	5	20+	Good	Fair. Well structured mature Pine in reasonably good condition. Some broken branches in crown.	Target prune broken/damaged branches.	9	255	B2
T109	Acer pseudoplatanus (Sycamore)	EM	10	583	3	0	4	5	5	4	20+	Good	Fair. Self-sown multi-stem coppice stool.	No urgent works needed.	7	154	C2
T110	Acer pseudoplatanus (Sycamore)	M	15	693	3	2	6	6	6	6	20+	Good	Fair. Mature tree located in private garden; not fully accessed or inspected. Tree appears to be in good health based on the observations made.	No urgent works needed.	8.32	218	B2
T111	Tilia X europaea (Common Lime)	M	16	750	1	0	8	8	8	8	20+	Good	Fair. Mature tree located in private garden; not fully accessed or inspected. Tree appears to be in good health based on the observations made.	No urgent works needed.	9	255	B2
T112	Acer pseudoplatanus (Sycamore)	M	18	900	1	1	9	9	9	9	20+	Good	Fair. Large mature tree located in private garden; not fully accessed or inspected. Tree appears to be in good health based on the observations made. Thick Ivy growth on tree stem.	Cut Ivy around stem base. Inspect stem/basal area.	10.8	366	B2

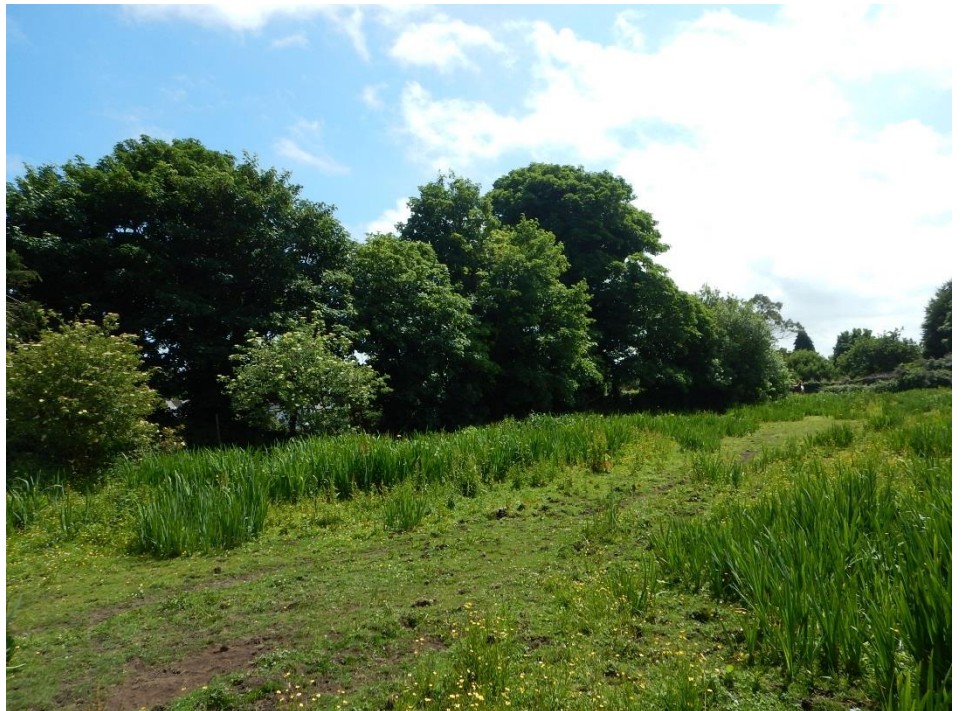
The linear tree group G4 (including trees T110-T112) extends just outside the eastern edge of the survey area; these trees are the largest and most significant individuals included in the schedule. The trees were not accessed directly and their dimensions were estimated, however their appearance indicates that they are good physiological condition and some would probably be classed as category A trees if no structural defects were seen during a more thorough inspection. There is likely to be significant root-spread out into the survey area from these trees; as indicated on the survey drawing.

Photo 8. Linear tree group G4 including some good quality Sycamore and Lime trees

G4	Acer pseudoplatanus (Sycamore) Tilia spp. (Lime)	EM M	10 to 18								20+	Good	Fair/Good. Linear group of mostly early mature and mature Sycamore trees growing in the rear gardens of the neighbouring properties. Trees were not fully inspected due to limited access; they appear to be in mostly good condition and some could be classified as category A when fully inspected and assessed.	No urgent works needed.			B2 C2
G5	Salix spp. (Willow) Betula pendula (Silver Birch) Alnus glutinosa (Alder)	SM EM	4 to 6								10+	Fair	Fair. Dense young scrub vegetation on land at the eastern edge of the wetland; separated from neighbouring gardens by deep drainage ditch. Trees look to be mostly naturally regenerated Willow bushes in fairly good health.	No urgent works needed.			C2

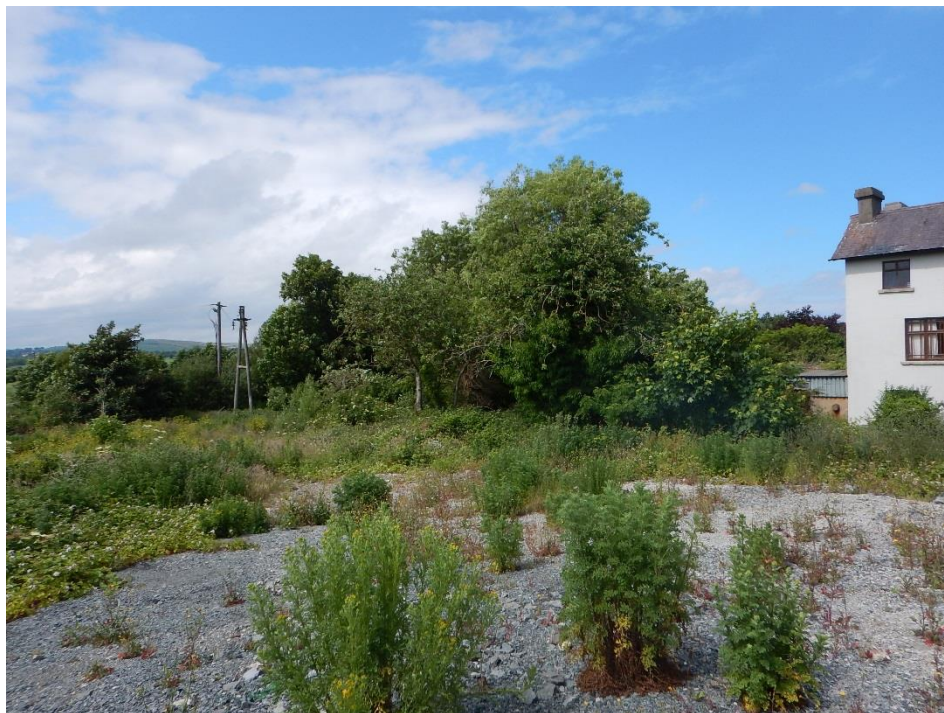
Photo 9. Cluster of trees (G6) immediately north of the bridge – on site of demolished building

G6	Salix spp. (Willow) Betula pendula (Silver Birch) Acer pseudoplatanus (Sycamore) Fraxinus excelsior (Ash) Malus domestica (Apple)	SM EM	7 to 12	200 to 300							10+	Fair	Fair. Small, linear cluster of trees and bushes; partly associated with the garden of the former nearby building (now demolished). Trees look to be in fair condition but are of limited value and potential.	No urgent works needed.			C2
G7	Salix spp. (Willow) Betula pendula (Silver Birch) Alnus glutinosa (Alder)	SM EM M	10 to 12								10+	Fair	Fair. Mixed tree-line along the northern bank of the Avoca River. Trees not subject to detailed inspection due to poor access. Trees are part of extensive group that create important landscape feature along the riverbank. Tree health looks to be reasonably good.	No urgent works needed.			B2 C2

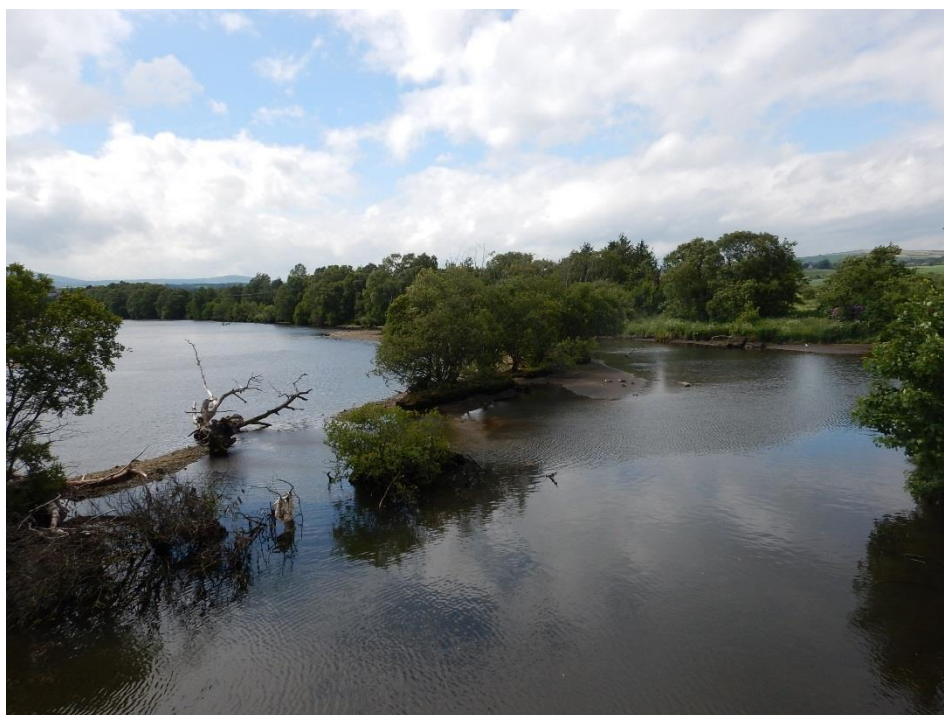
The north bank of the Avoca River and several small islands are covered by mixed trees and bushes; mostly Willow species but also including Alder, Ash, Birch and Sycamore of moderate to low value. There are some coniferous trees (including Pine and Cypress) close to the western edge of the survey area, just north of the riverbank, however these trees were not accessed or inspected in any detail.

Photo 10. Willow bushes on small islands in the river and riparian tree-line along the northern river bank just north-west of the bridge
