# Annual Environmental Report

2023

Kilmadthomas

D0275-01

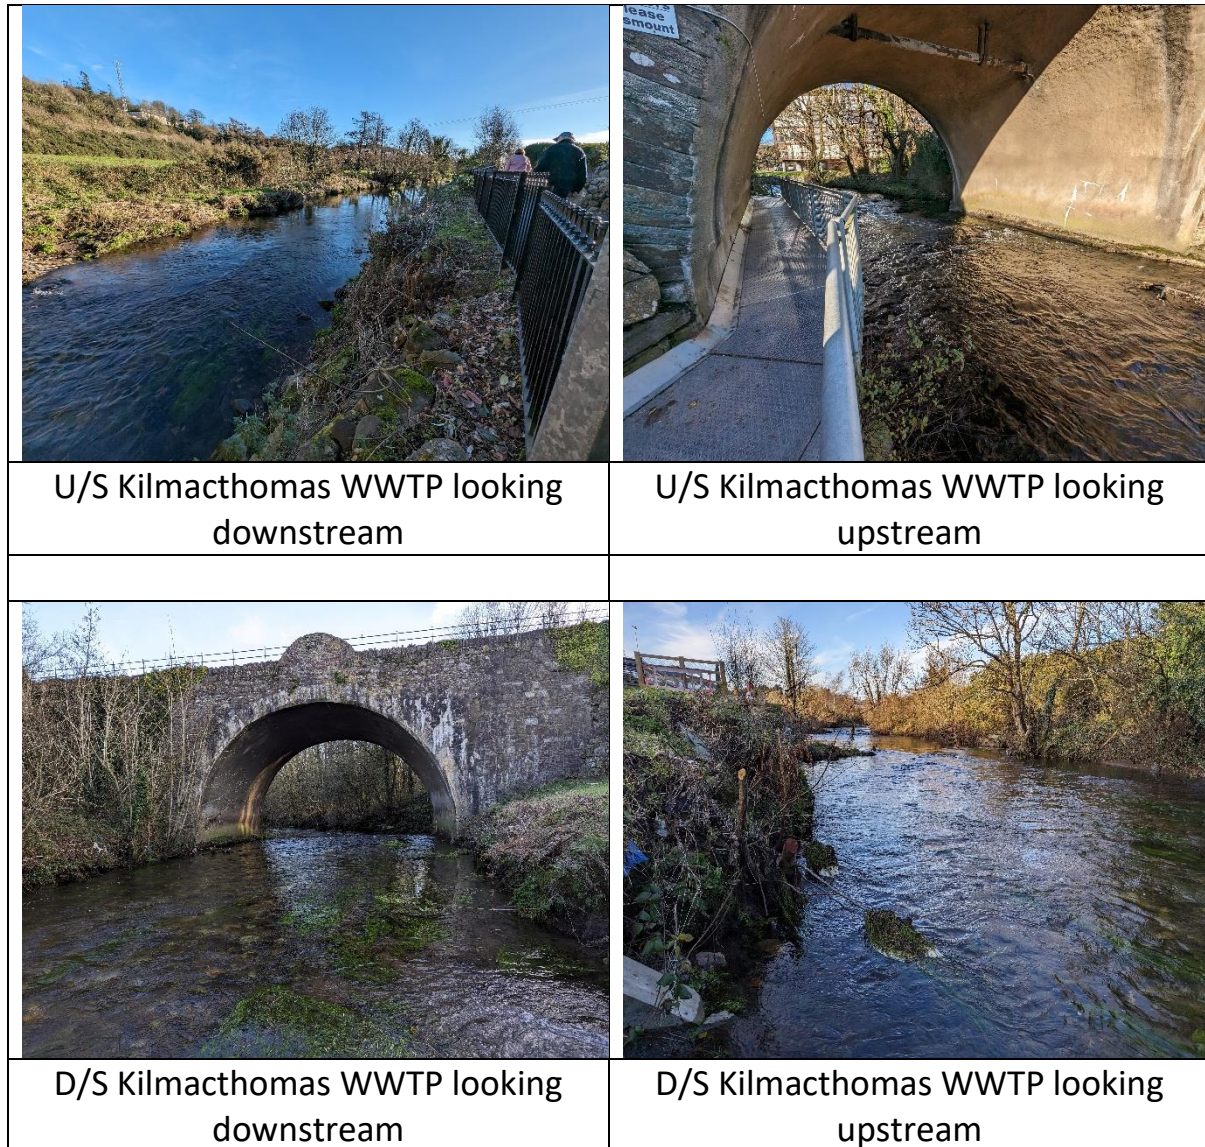
**Figure 2. Upstream (U/S) and downstream (D/S) of Kilmacthomas WWTP.**

Figure 2 shows photographs taken when sampling at Site 1 and Site 2 upstream and downstream of the Kilmacthomas WWTP on 5 December 2023.
